Renewable Energy Generation - Rehabilitation of Pile Foundations for Solar Photovoltaic (PV) Ground Mounted Systems affected by Frost in Ontario, Canada

*¹Kibriya T PhD and ²Tahir L

Abstract

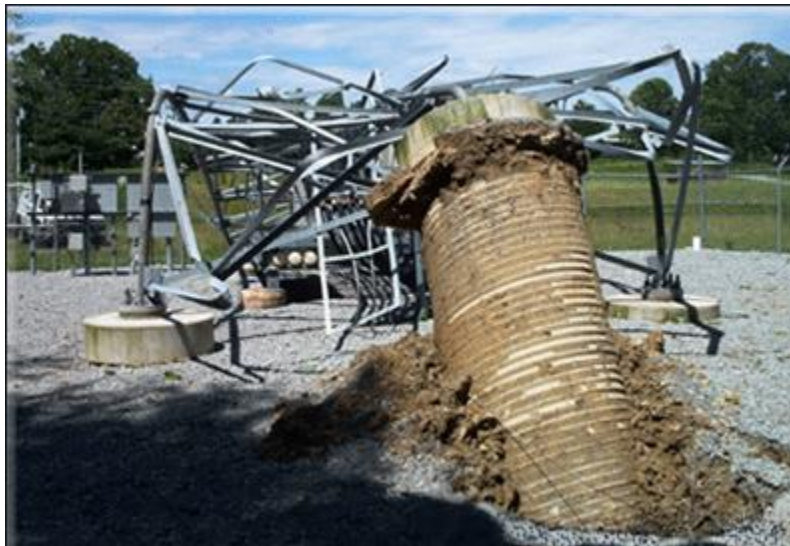
Figure 1. Tower foundation failing under effects of uplift and frost

Effects of frost heaving can be devastating. Frost heaving has displaced wood piling upward as much as 14 inches in a single winter season on an Alaska railroad bridge near Fairbanks, Alaska. About 24 inches of frost heaving of piles has been recorded in a single year in Russia. About 8" of uplift has been recorded for a bridge piles at Norman Wells, Northwest Territory, Canada. The maximum recorded cumulative heaving of a pile in a Russian bridge is about 6½ feet. Piling of a bridge 8 miles southeast of Big Delta, Alaska, has been frost heaved by 11 feet. Frost heaving combined with wind uplift can overturn communication towers as shown in Figure 1 below.

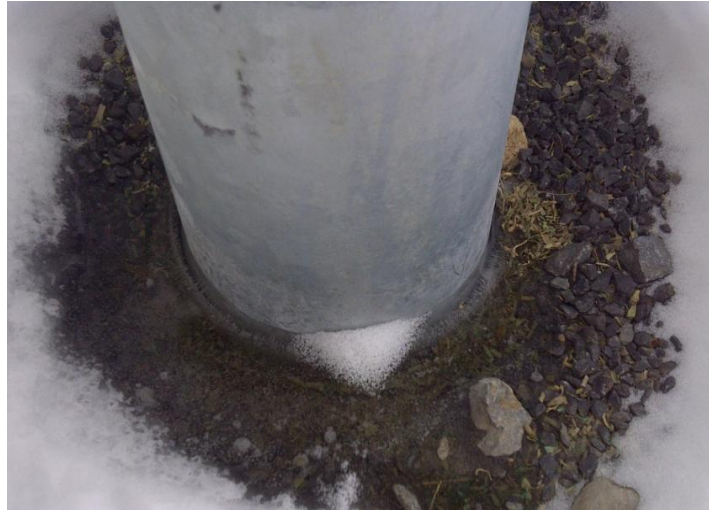
Figure 2. A pile moving out due to frost. The movement can be observed at the base of the pile

In case some piles are visually observed to have heaved, a complete survey of the area is usually carried out to establish the extent of damage and the precise amount of heave which has occurred. Figure 2 below indicates a pile which has been affected by frost. It is quite rare that complete rows of piles experience uniform heave, though such

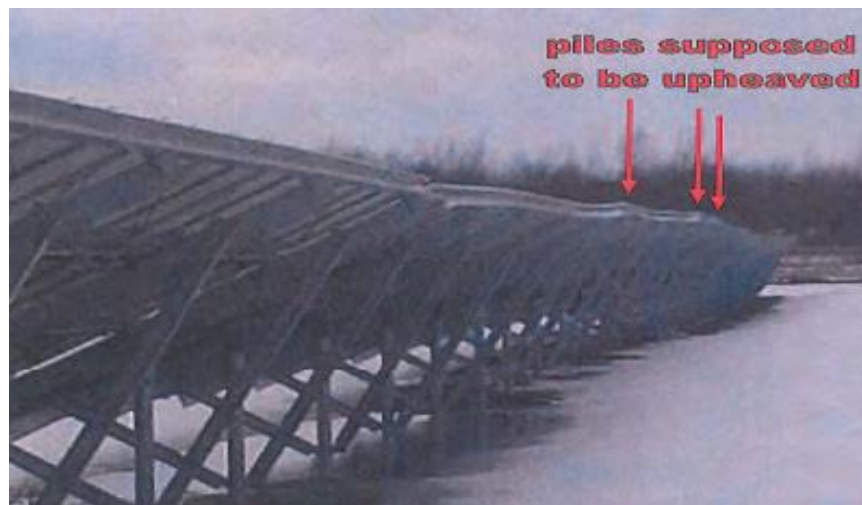
Figure 3. Piles affected by frost showing deformation of the racking

heave will not create much of issues for the facility. Usually a number of piles in each row will experience pile heave while others will not be affected. The piles experiencing heave are usually observed to experience different values of uplift which are rarely uniform as can be seen in Figure 3. The generally acceptable limits of pile heaving are 36mm of differential heaving based on IEC 61646 (Thin-film terrestrial photovoltaic (PV) Modules – “Design qualification and type approval”) since beyond these limits, excess torsional stresses are induced in the solar panels along with additional flexural stresses induced in the racking beams possibly causing structural damage in addition to the connecting wires and connections getting into failure/breakage due to induced tension.
